**Inspection Address:**

Clarksville, TN

## Report Overview

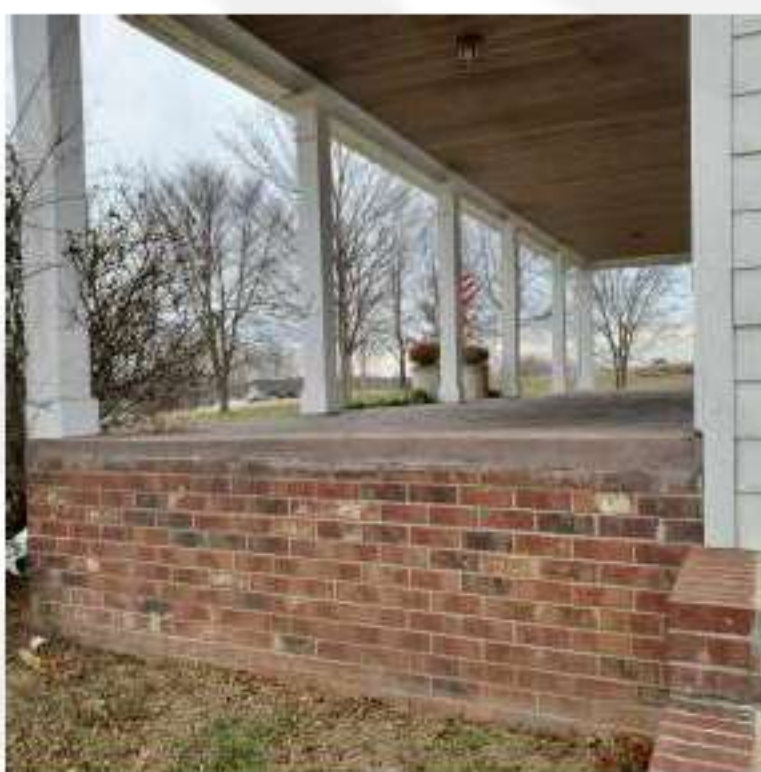
A. A railing should be installed on right side of front porch for safety

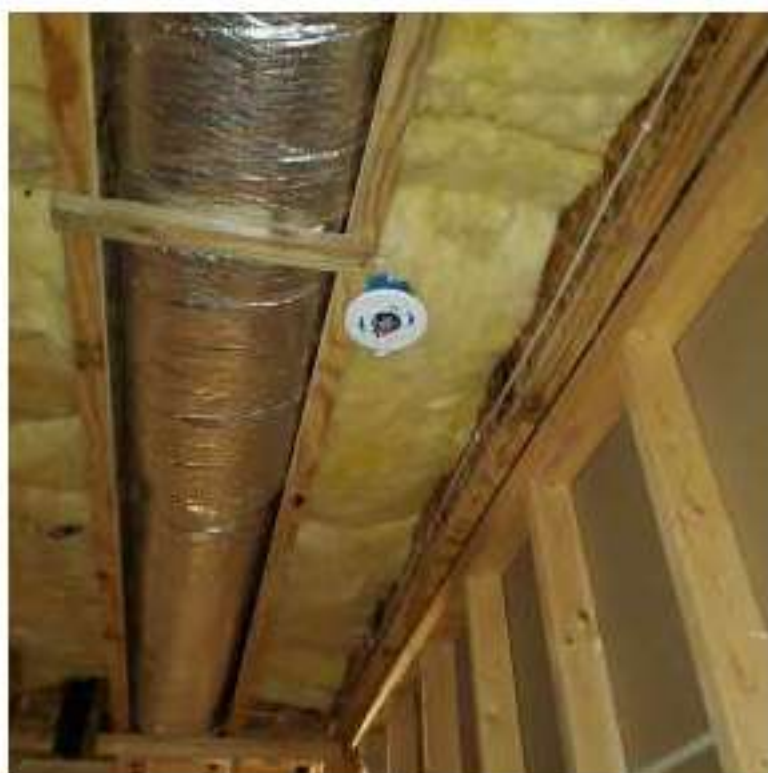
B. Missing smoke detector on ceiling in unfinished basement

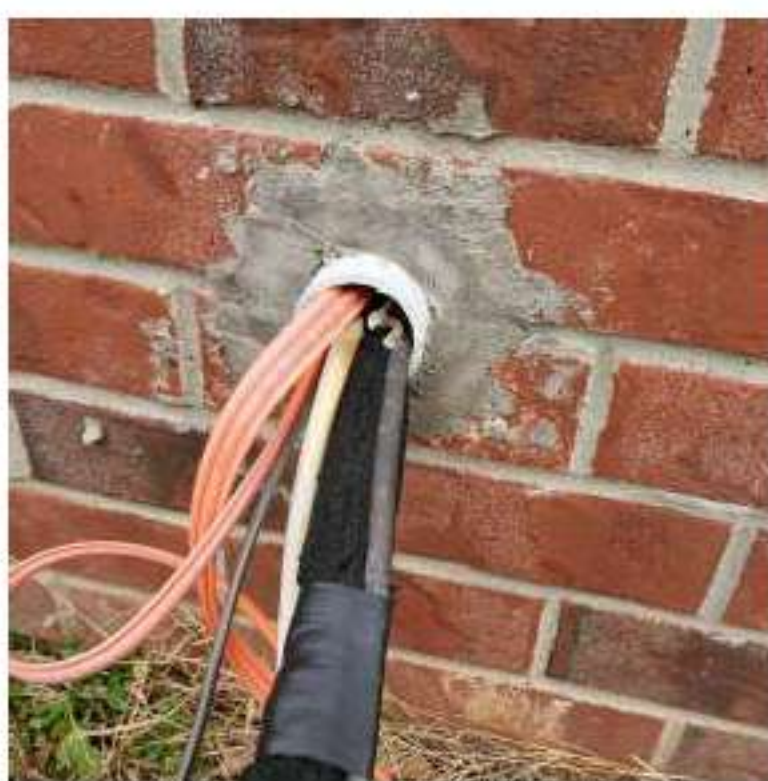
A. Holes for condenser pipes on left side of house should be sealed

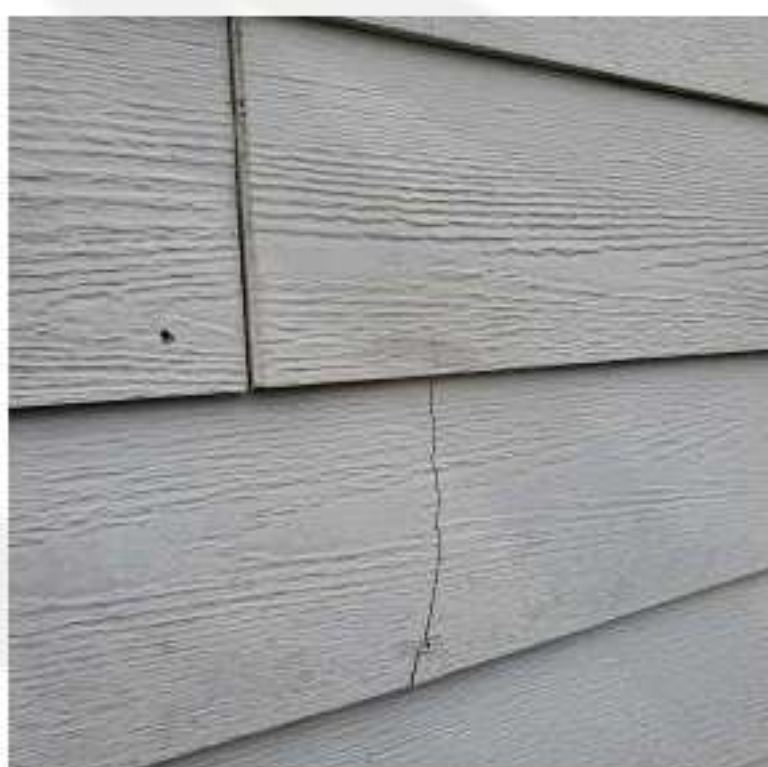
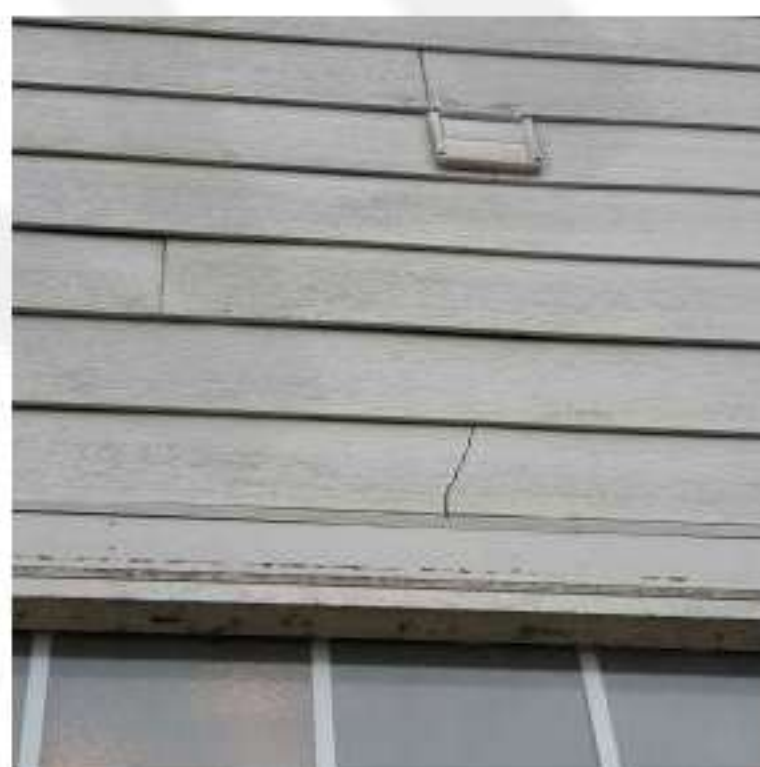
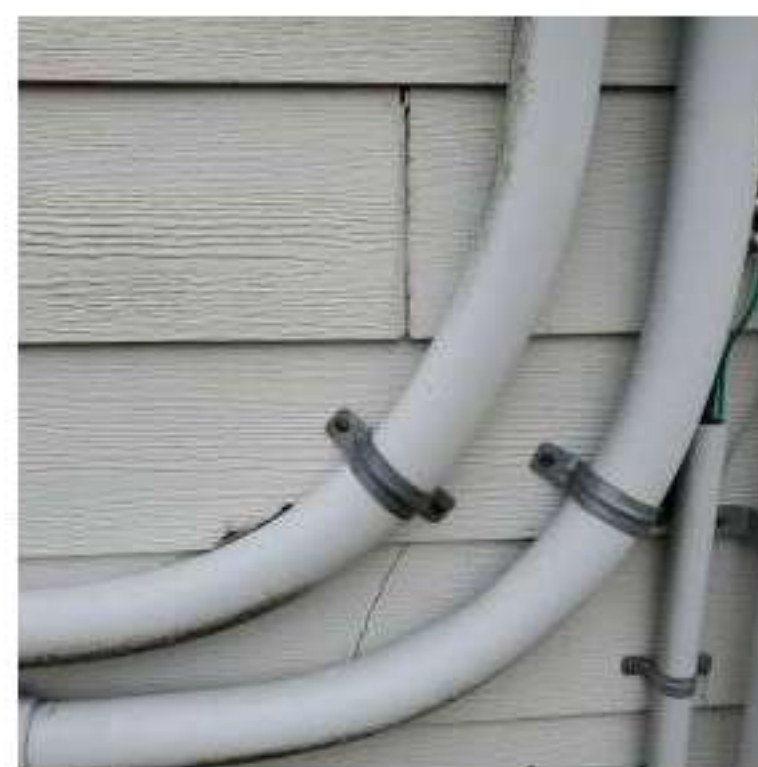
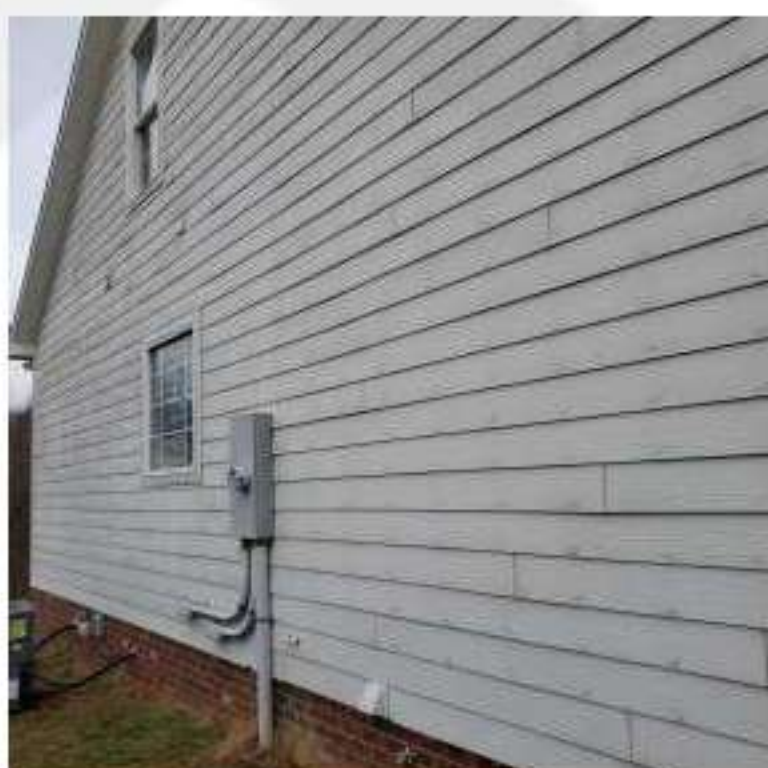
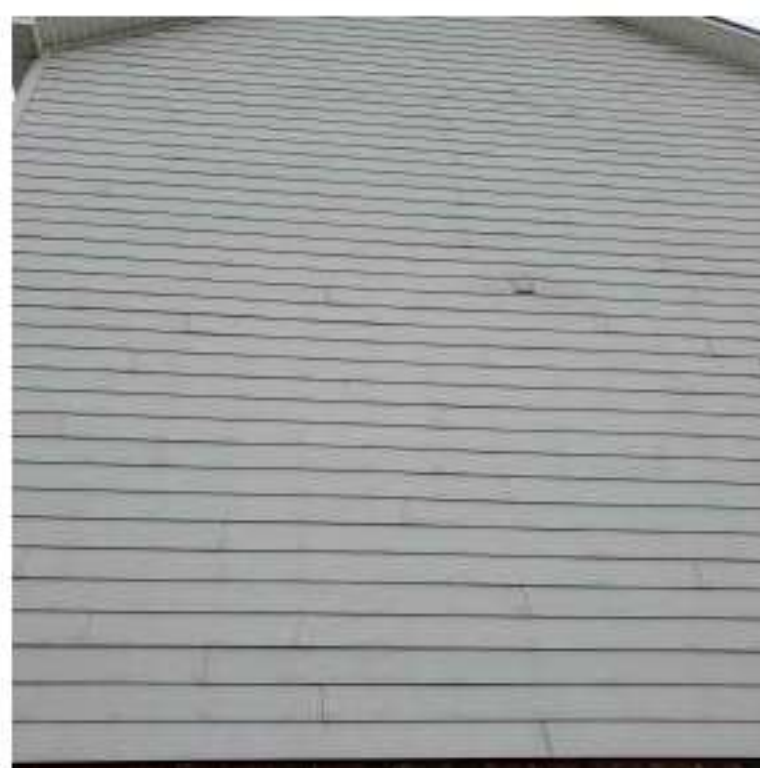
B. Recommend sealing gaps and cracks along siding on all sides of house

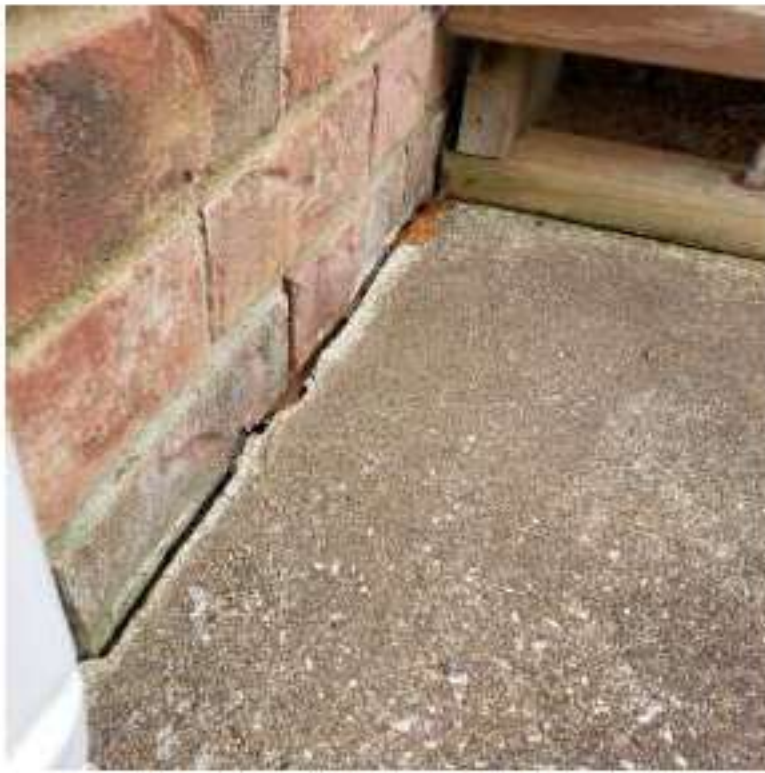
C. Gap between concrete landing and brick siding at back right corner of house should be sealed

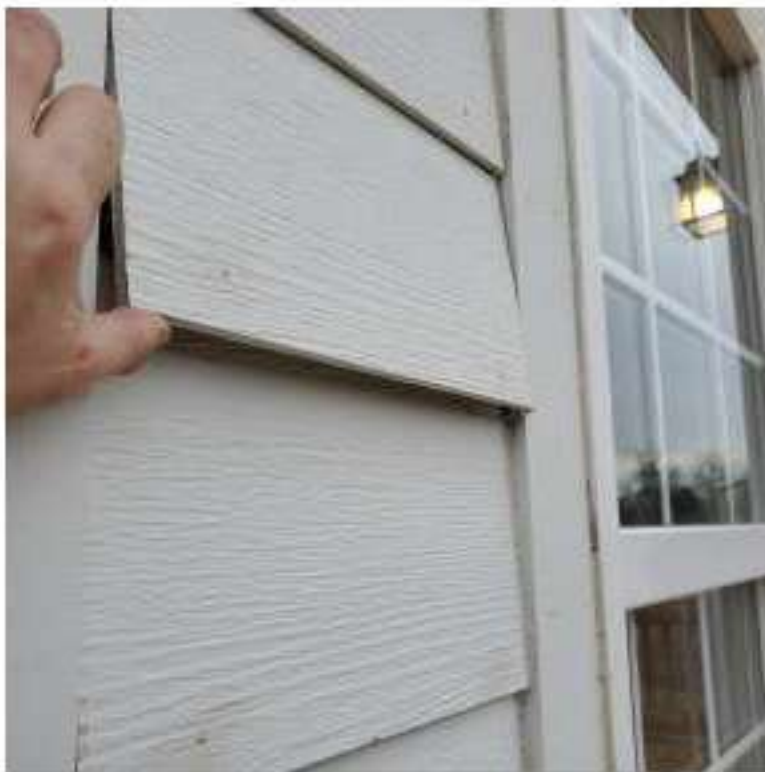
D. Siding was loose near top of stairs to back deck

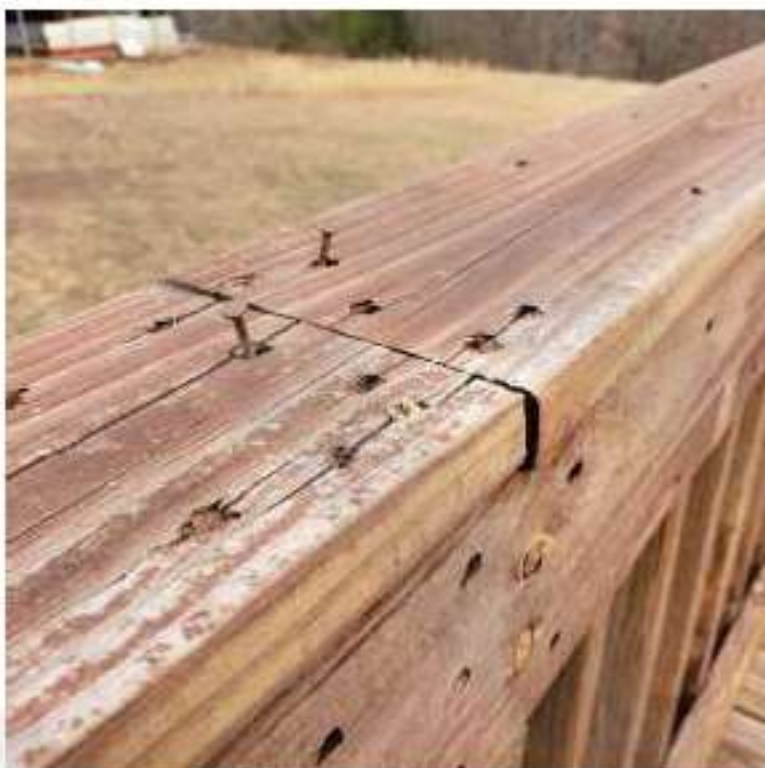
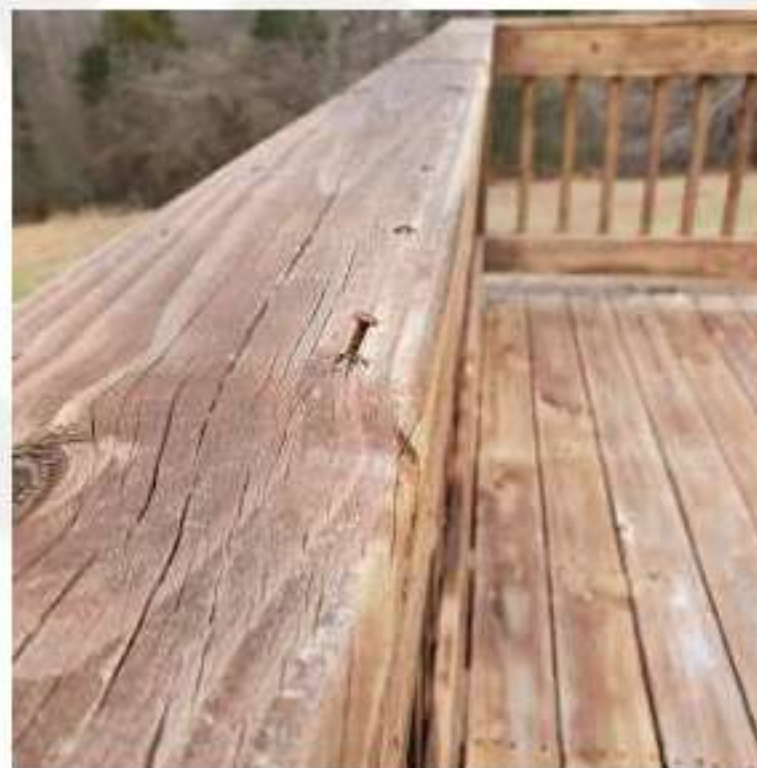
E. Popped nails on handrail of back deck should be properly secured

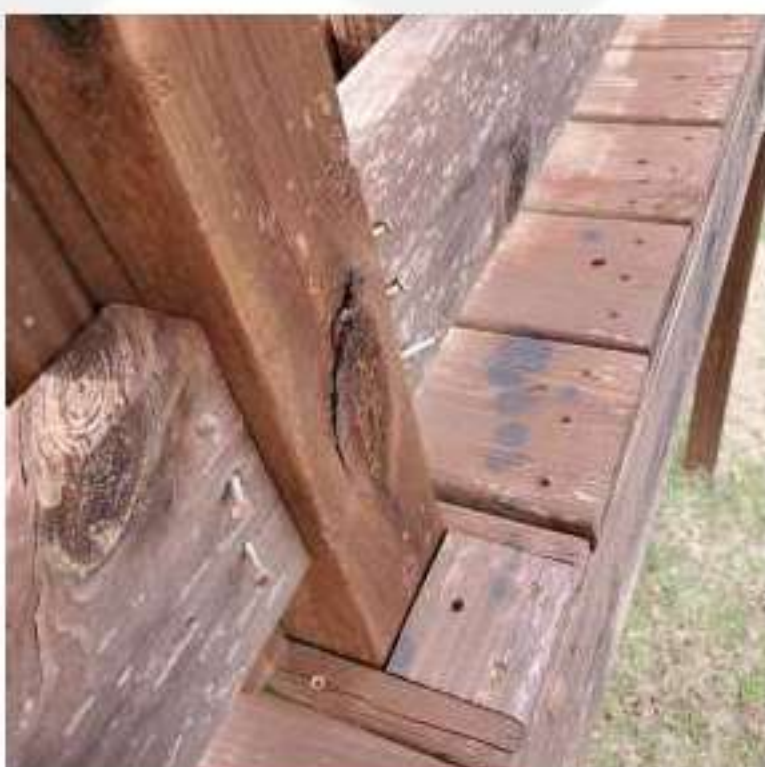
F. Nail securing railing to post on right side of back deck should be secured

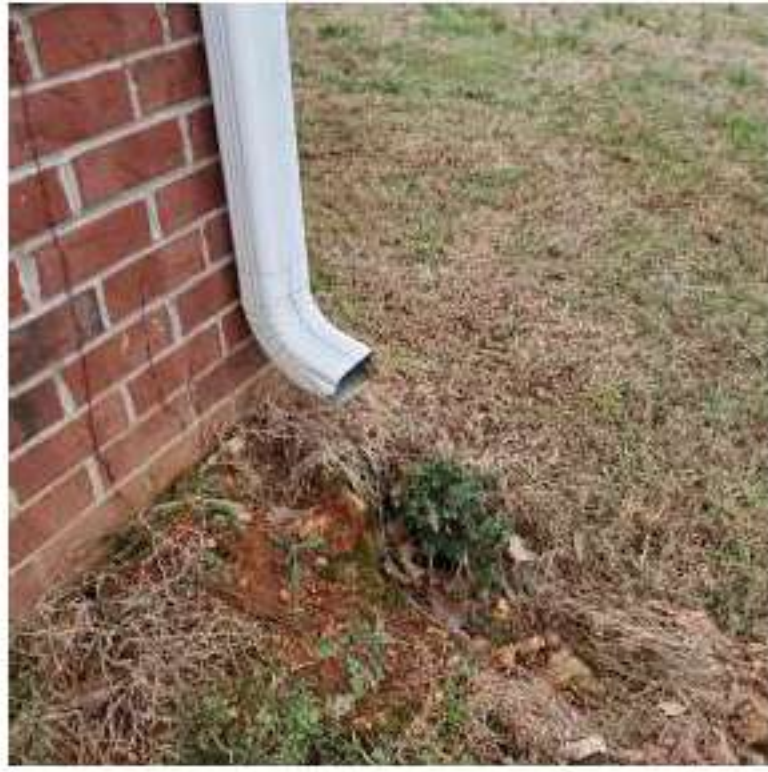
## G. Missing drain pan under downspout at back left corner

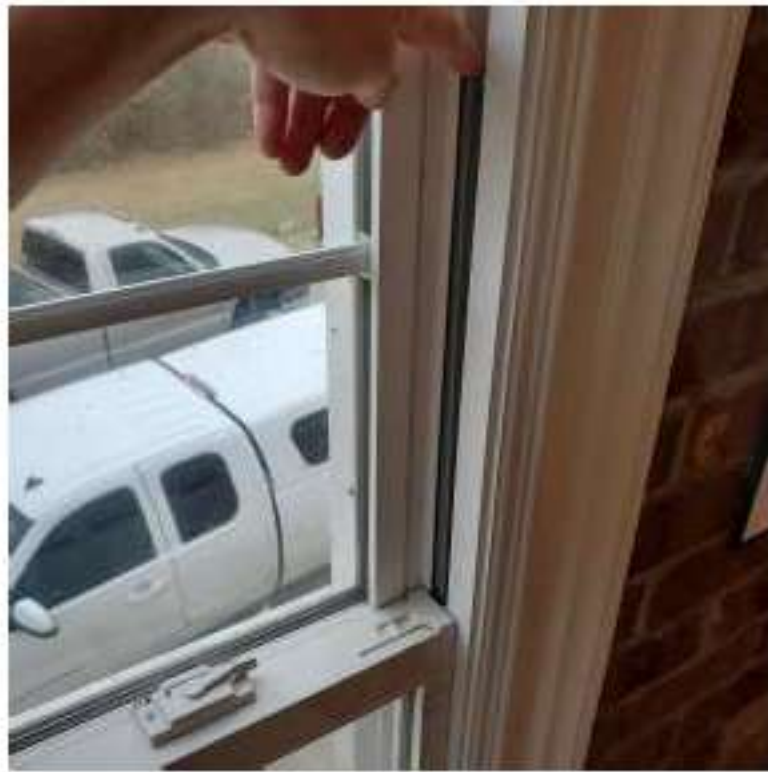
A. Lower sash rail on right side in dining room near kitchen countertop was disconnected

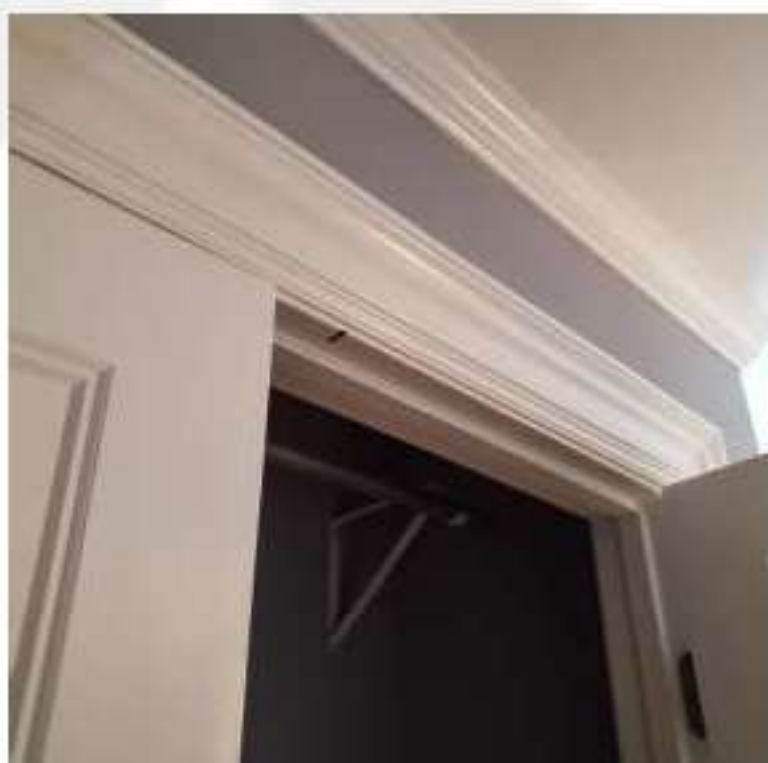
C. Missing latch hardware for closet doors in front right bedroom on second floor

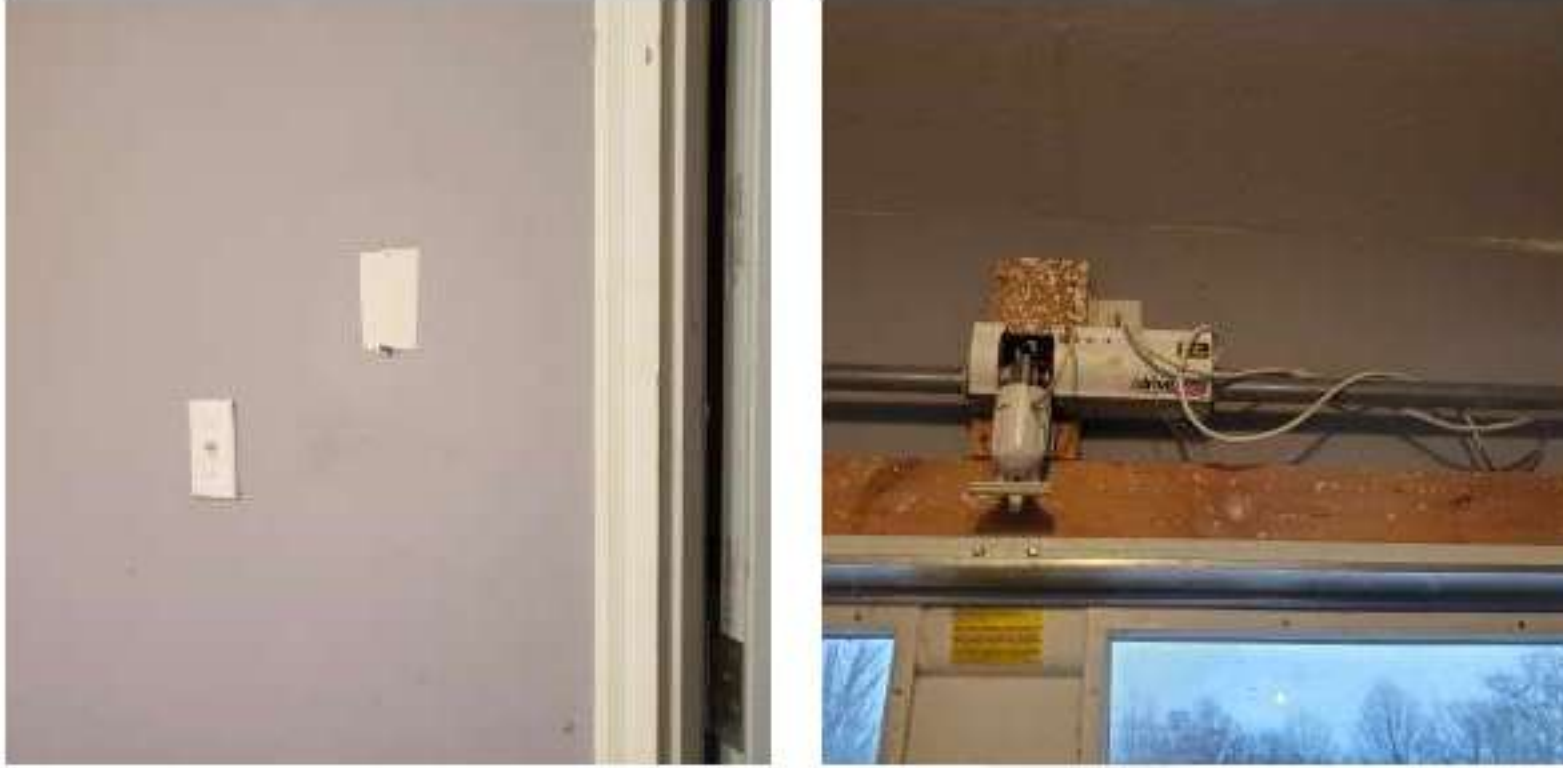
F. Control for garage door was missing. Garage door could not be tested at time of inspection

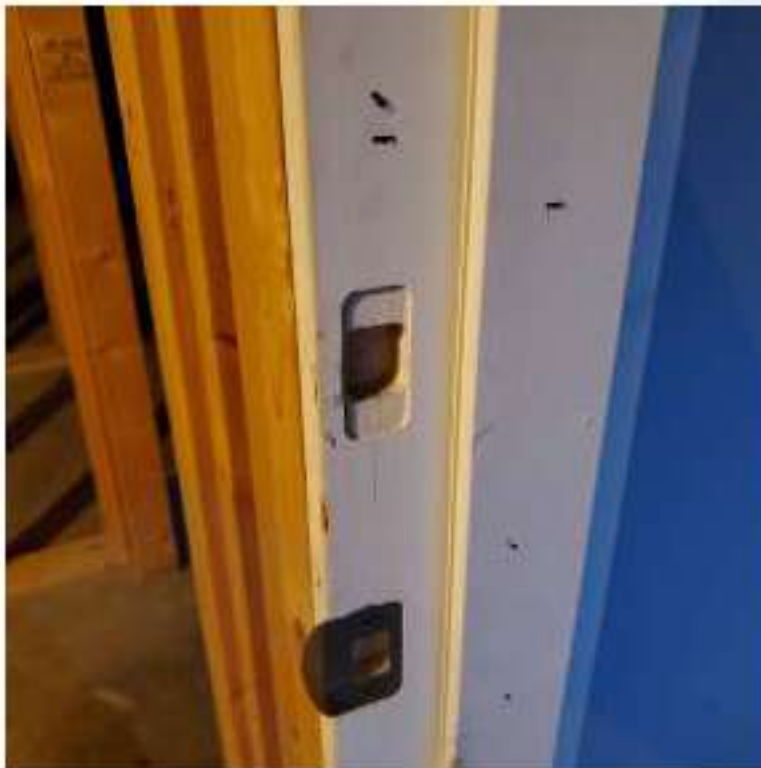
G. Strike plate for deadbolt to garage door in basement was missing

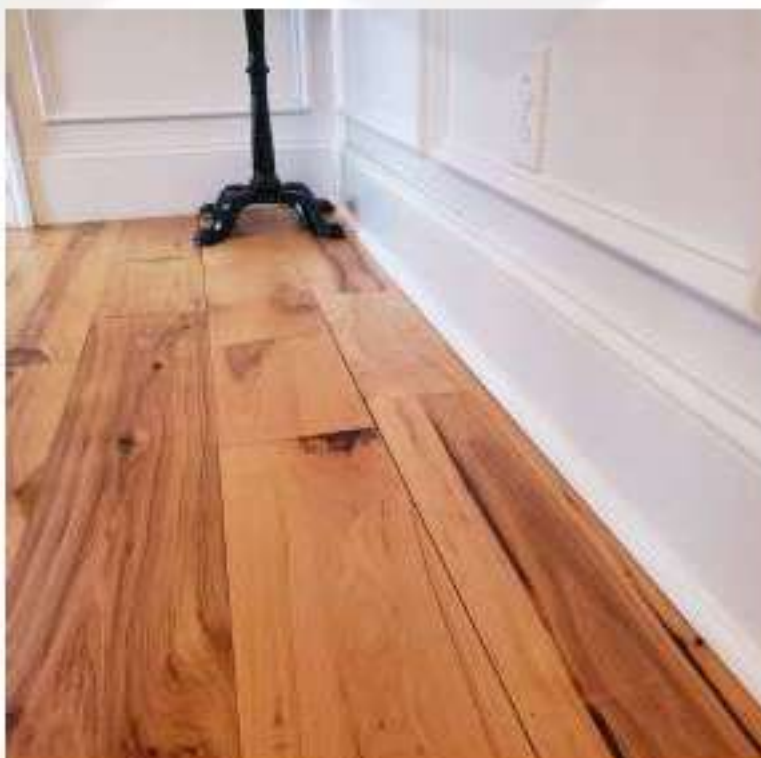
A. Floor planks were raised in corner of dining room. This can occur when during installation, they do not leave adequate room between flooring and walls for slight movement over time

Windows were sealing and functioning properly. Most doors were properly aligned to jambs. Floor planks in dining room were heaving likely due to improper installation.

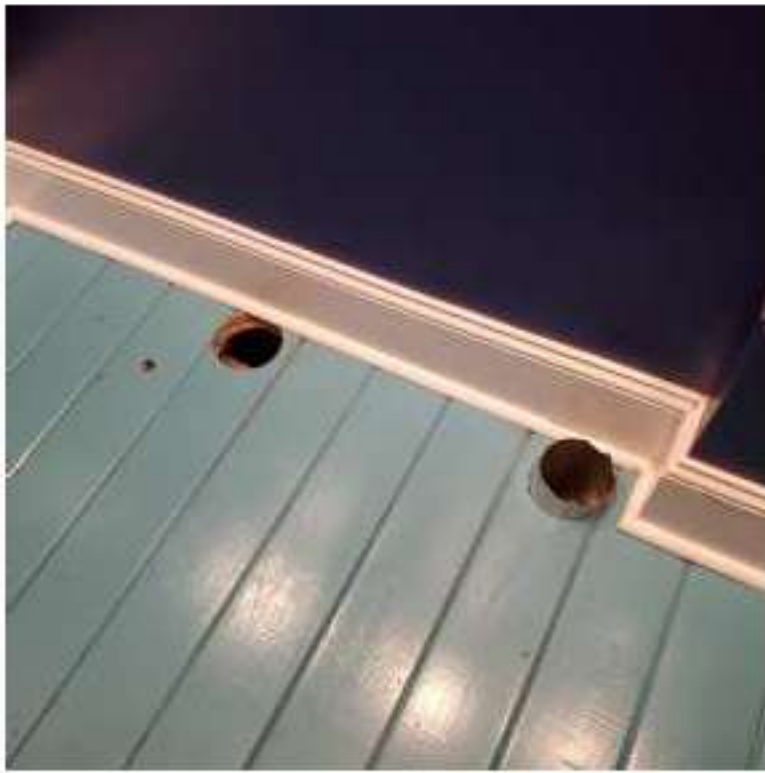
**B. Recommend sealing unused dryer duct hole in floor of laundry room**

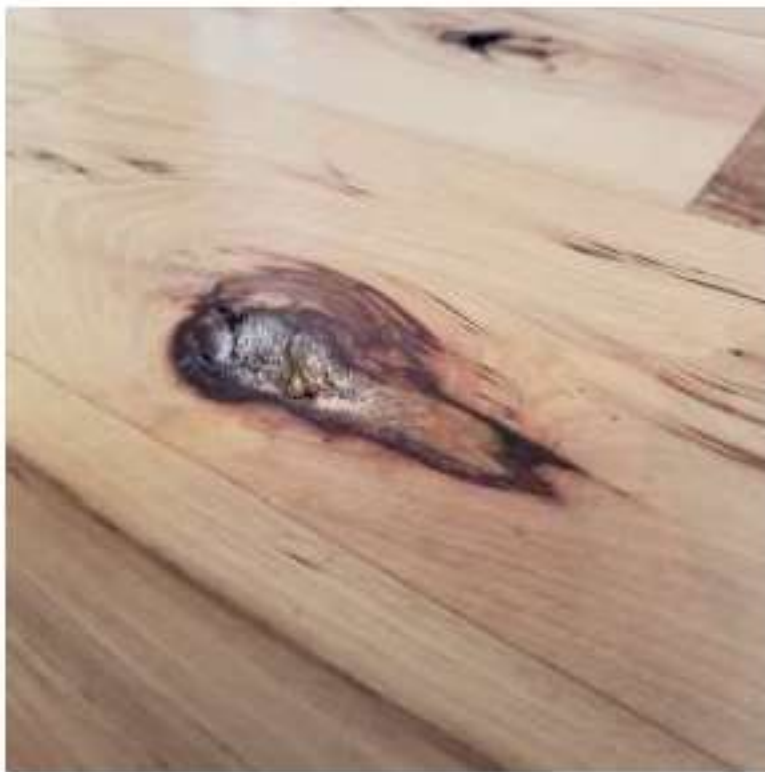
**C. Recommend sealing hole in floor from wood knot near hallway bathroom on first floor**

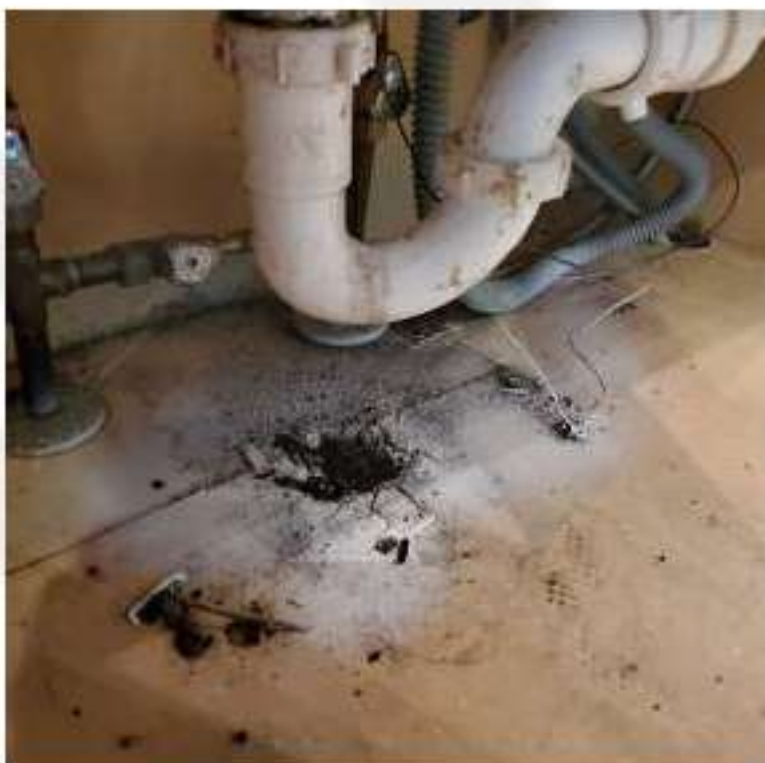
**A. Cabinet under kitchen sink was damaged from previous moisture leaks. Area was dry at time of inspection**

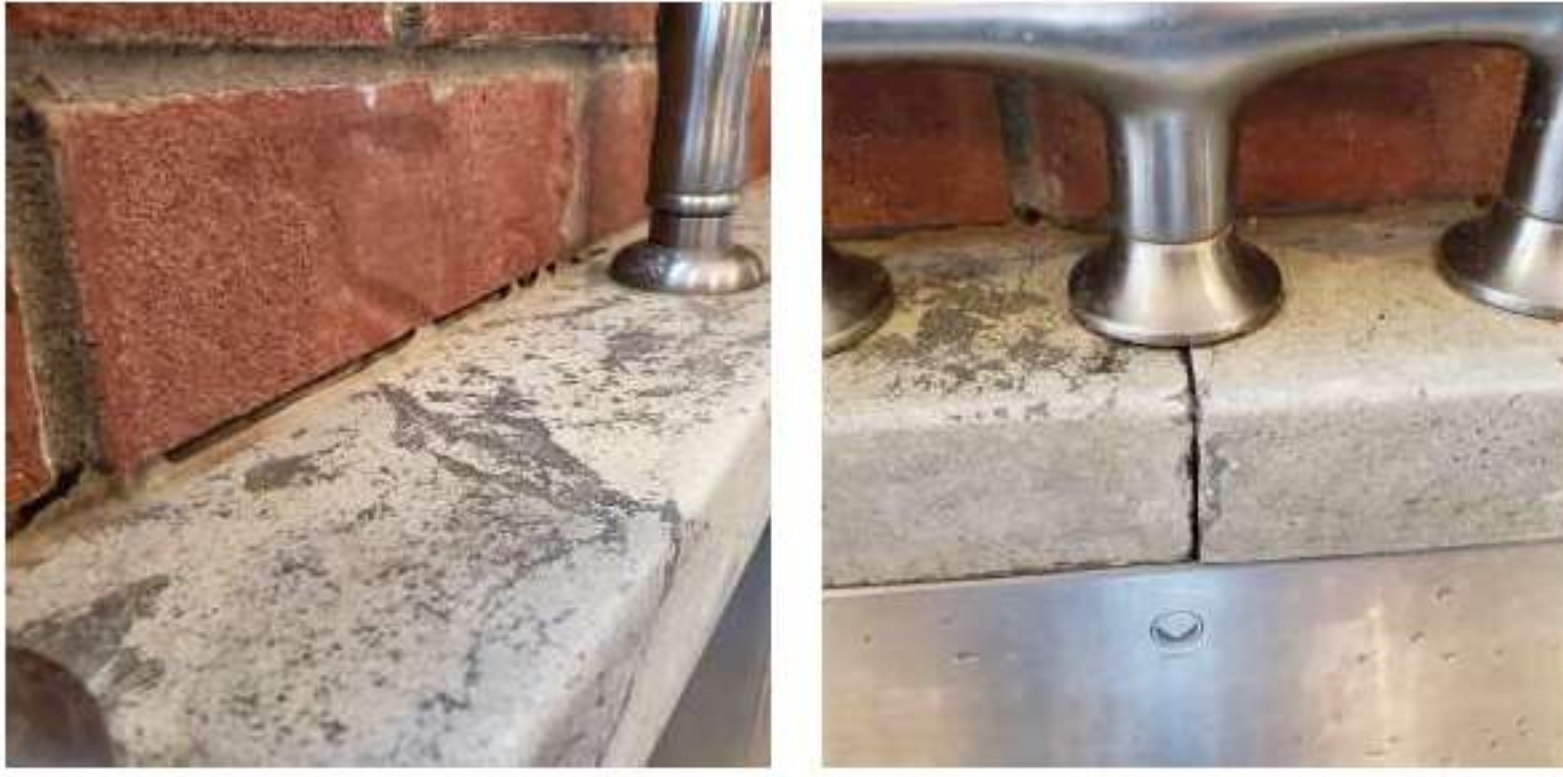
**B. Gaps along countertop near sink in kitchen should be sealed to prevent moisture penetration**

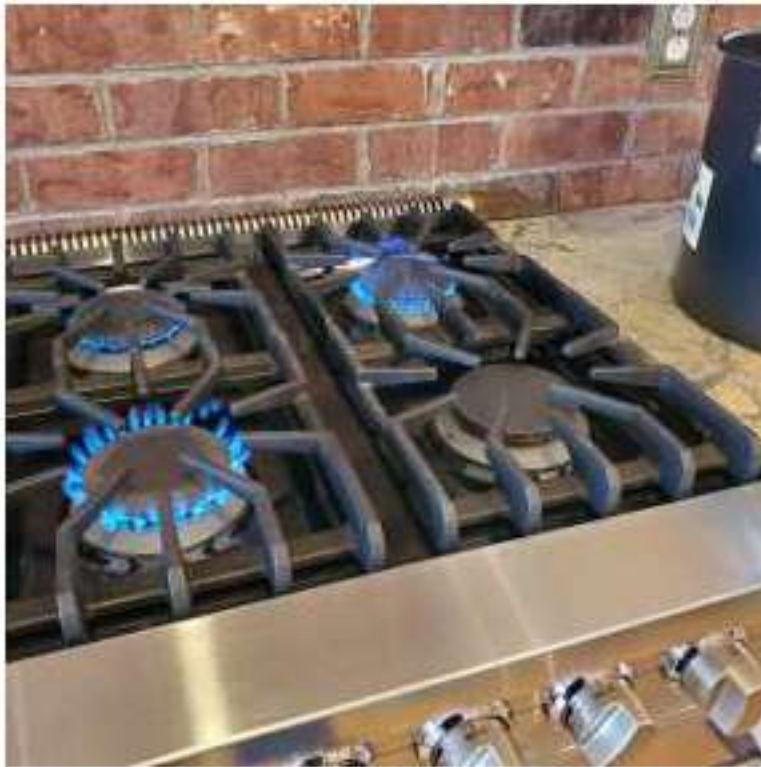
C. Front right burner on range would not turn on during testing. Recommend further evaluation by a technician

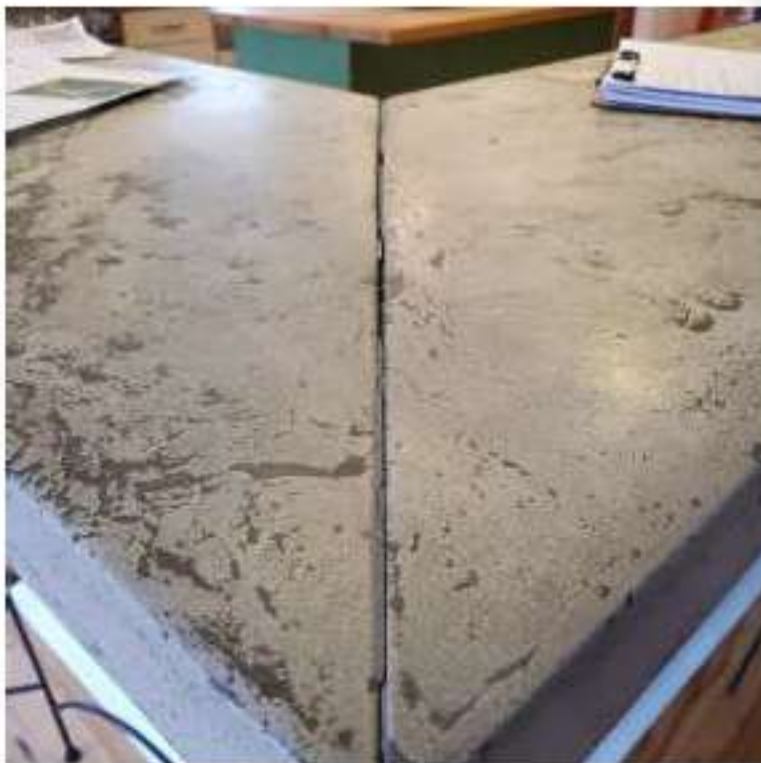
D. Loose grout along corner of bar top in kitchen should be sealed

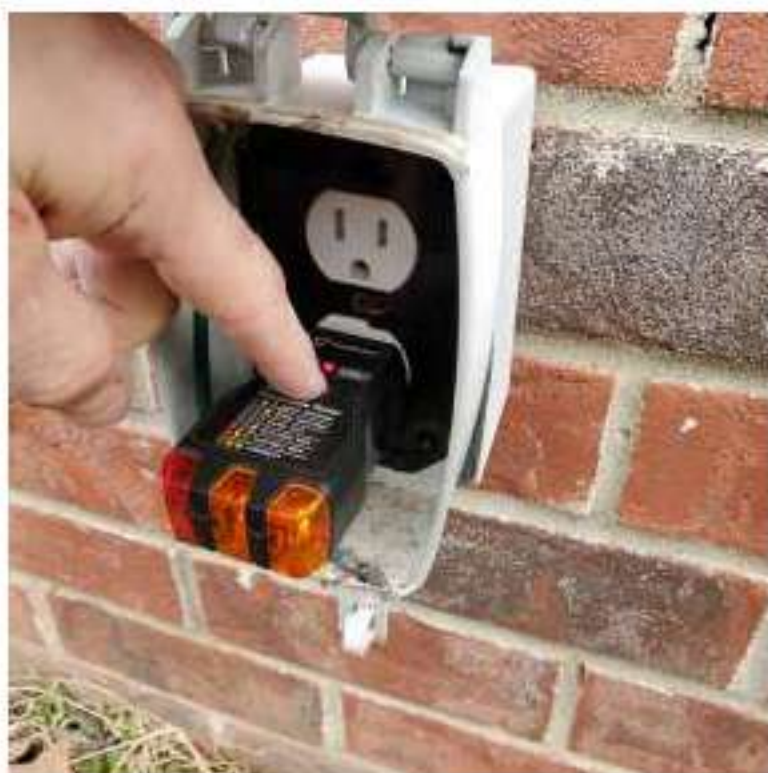
A. Exterior outlets failed GFCI testing. Recommend further evaluation by a licensed electrician

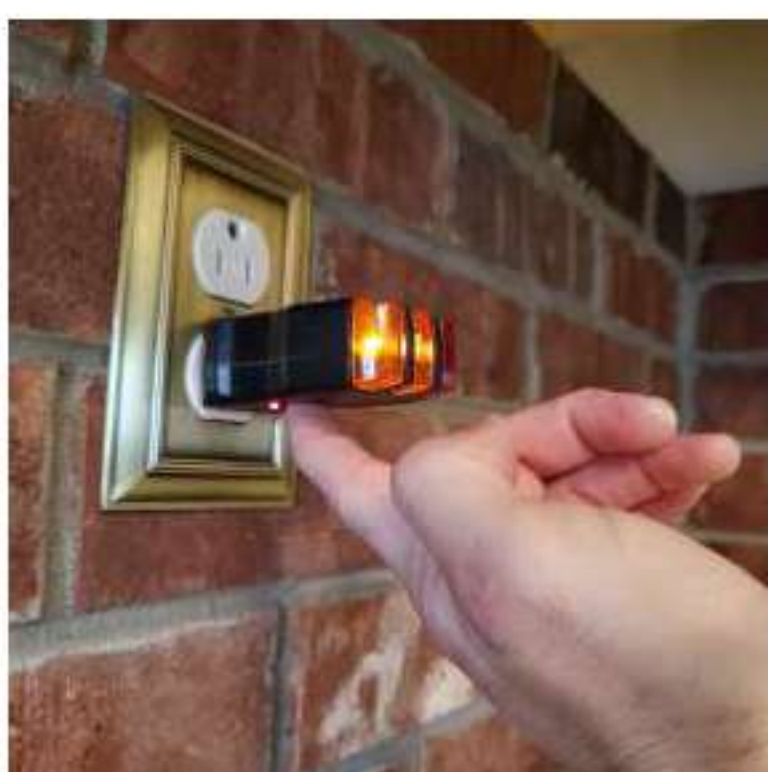
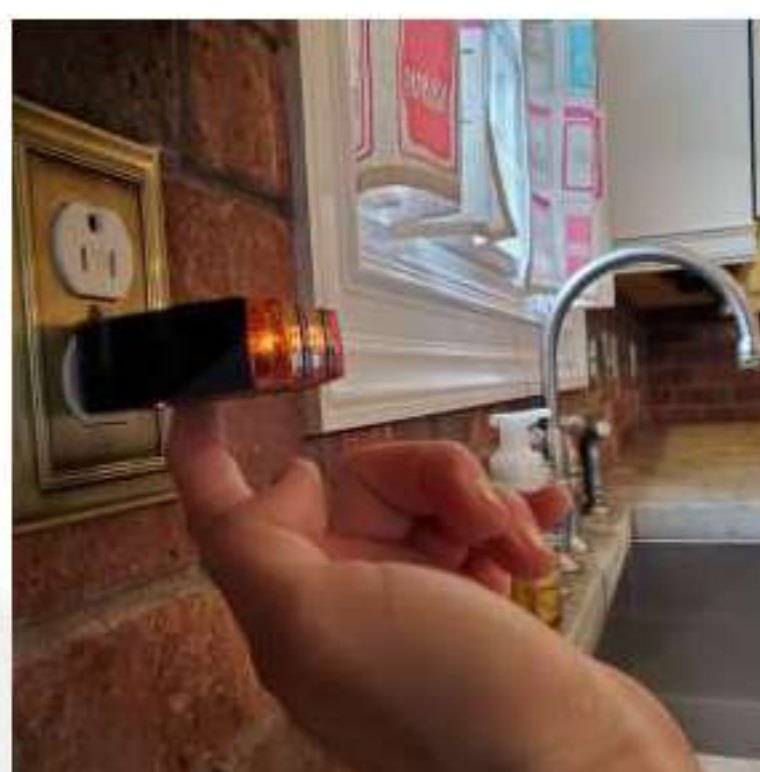
B. Outlets along backsplash near sink, dishwasher and oven in kitchen failed GFCI testing

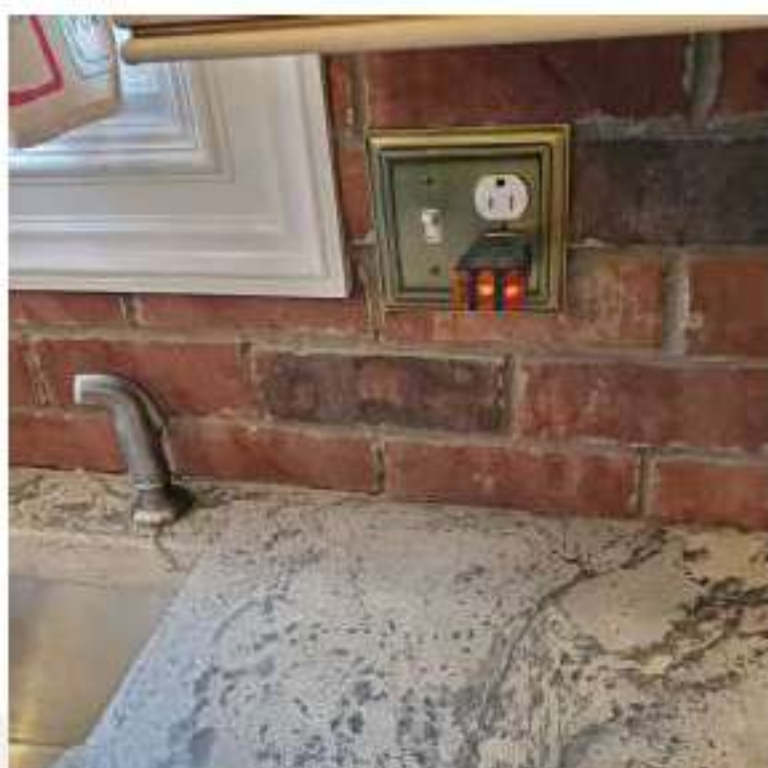
C. Outlet on right side of kitchen sink was reversed polarized (hot and neutral reversed)

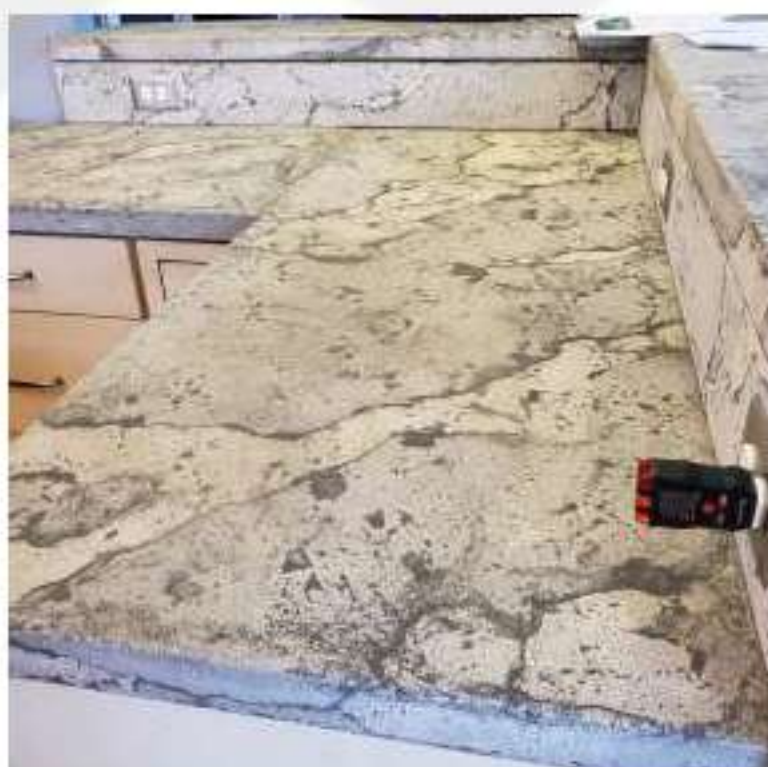
D. Outlets along countertop on left side of kitchen were not GFCI protected

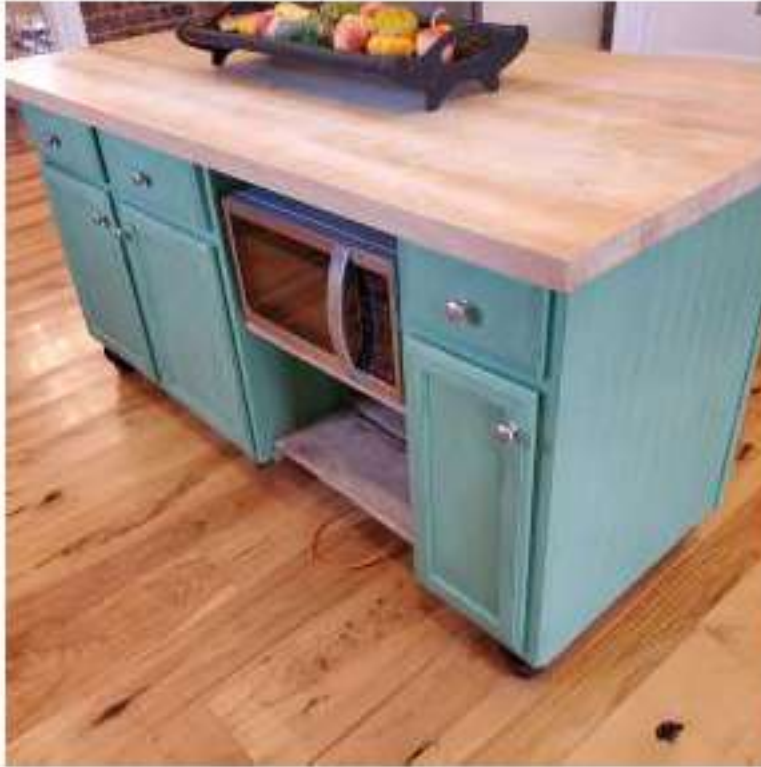
E. Extension cord was drilled through floor to power microwave on island in kitchen. Extension cords should not be used as permanent electric wiring. Island should be properly secured to floor. Recommend further evaluation by a licensed electrician

Front right burner on range would not light during testing. Island should be properly secured to floor once electric cable is properly installed.

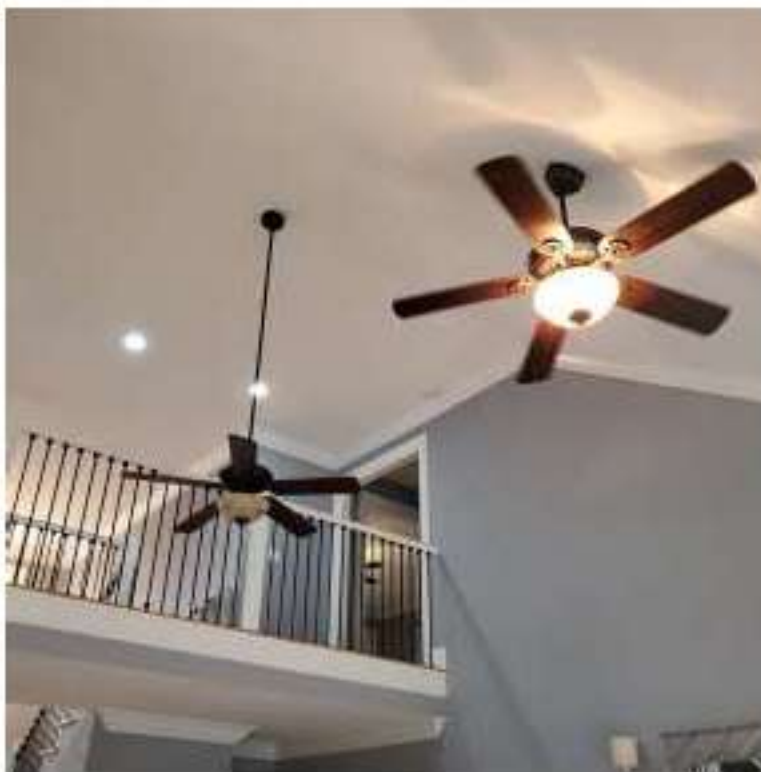
F. Ceiling fan light in living room would not turn on (likely bulb issue)

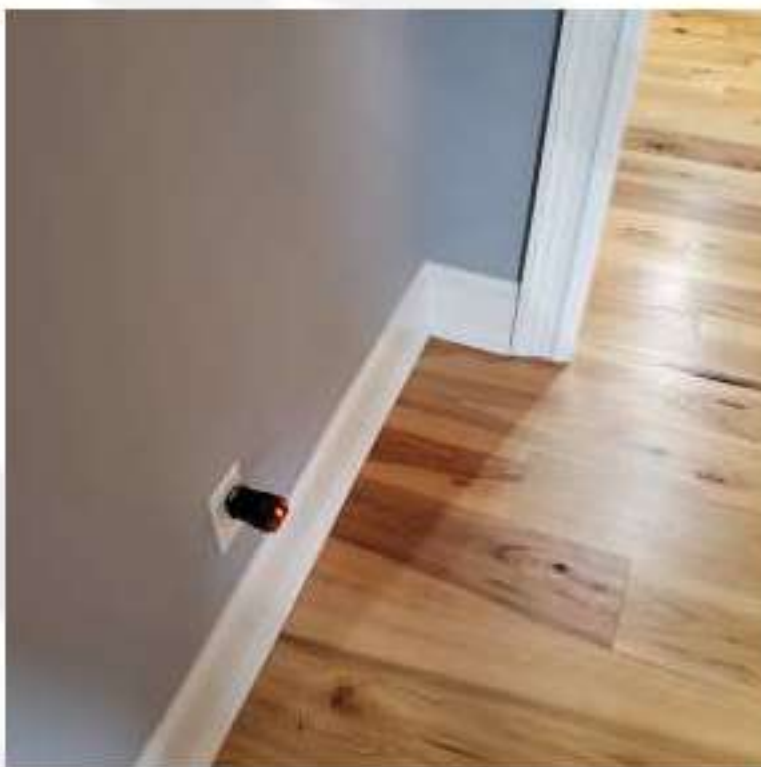
G. Outlet near entrance to room above kitchen was reverse polarized

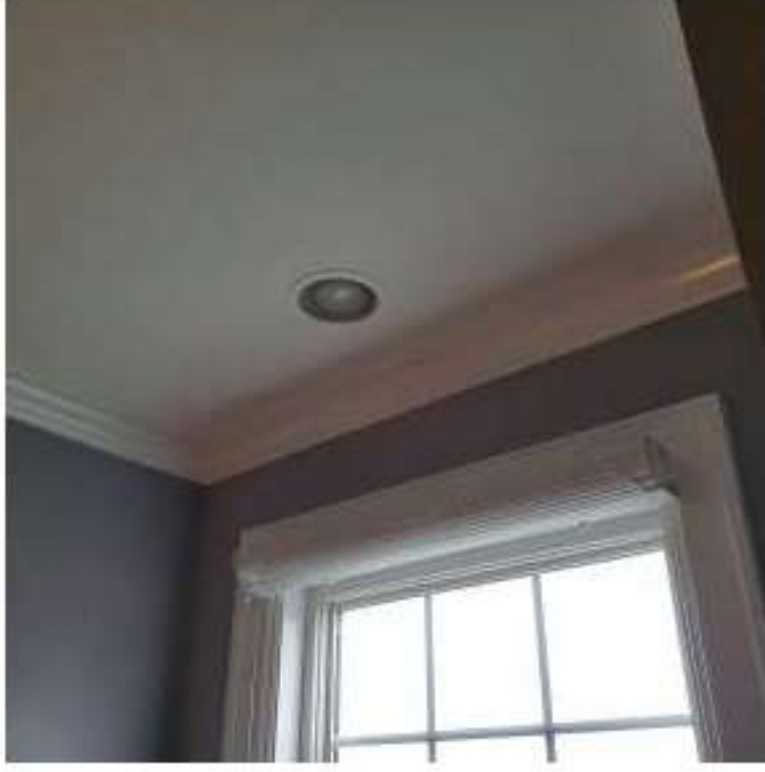
H. Recessed light near window in front left bedroom on second floor would not turn on (likely bulb issue)

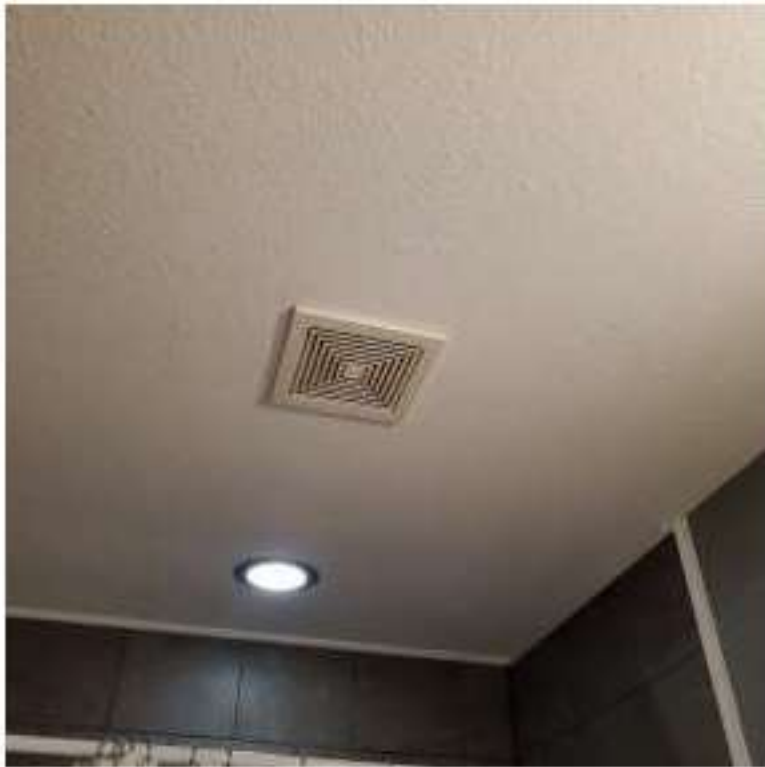
I. Ceiling fan in hallway bathroom on second floor would not turn on during testing
