**Inspection Address:**

Clarksville, TN

## Report Overview

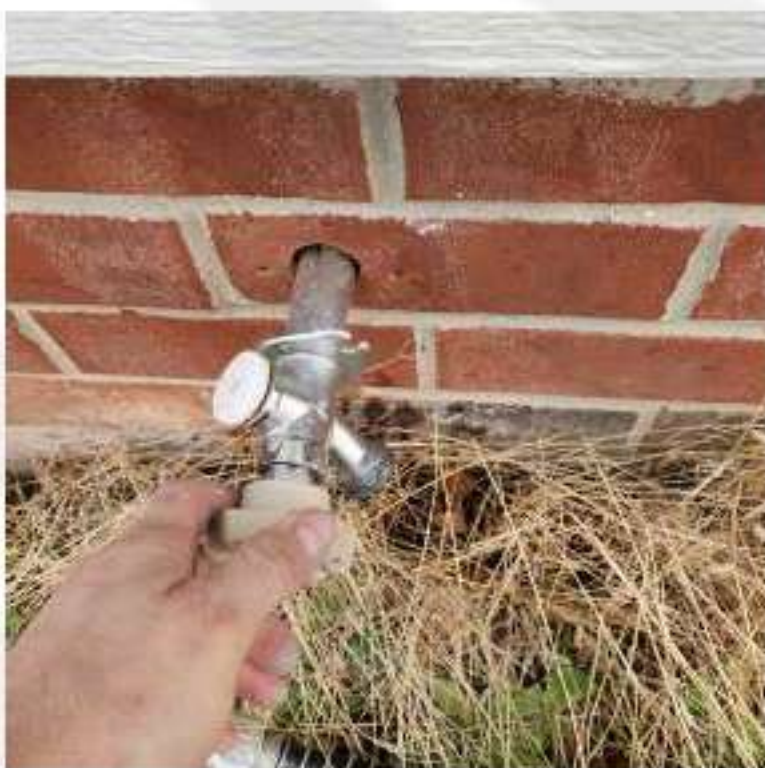
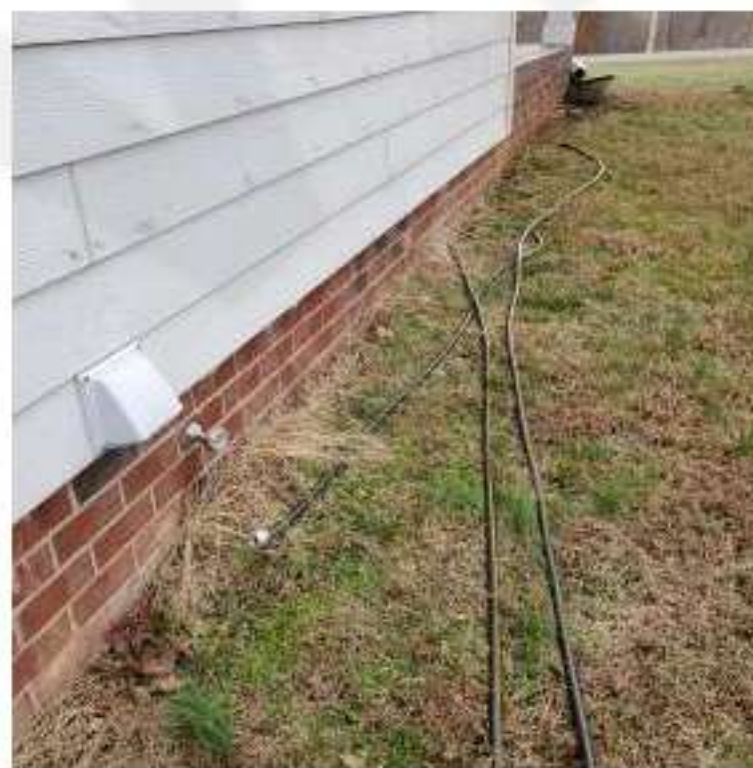
A. Exterior spigot on left side of house was loose and should be properly secured

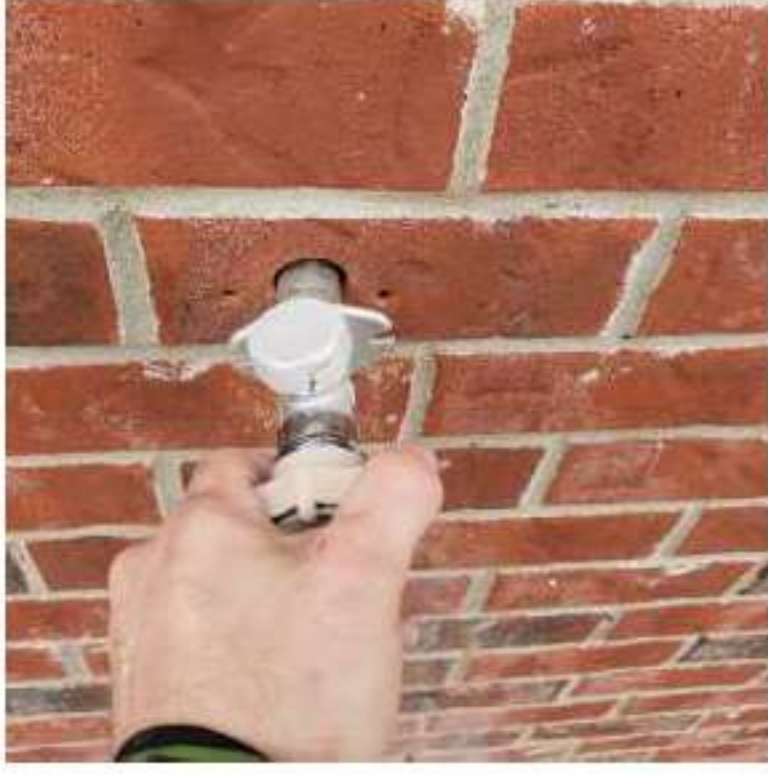
B. Exterior spigot near garage door on right side of house was Lewis and should be properly secured to siding. Spigot was not functioning at time of inspection

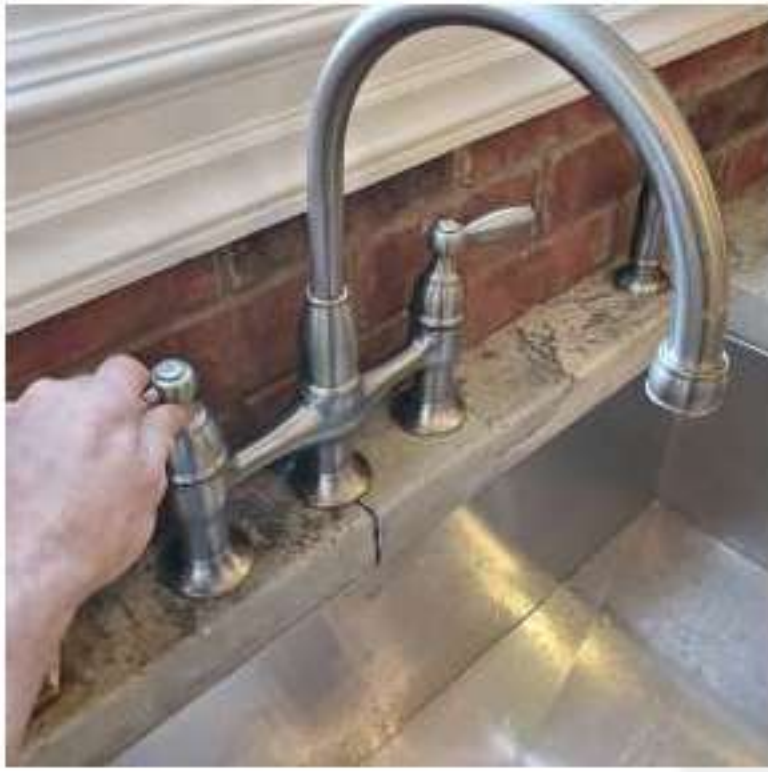
C. Kitchen sink faucet was loose and should be properly secured to counter

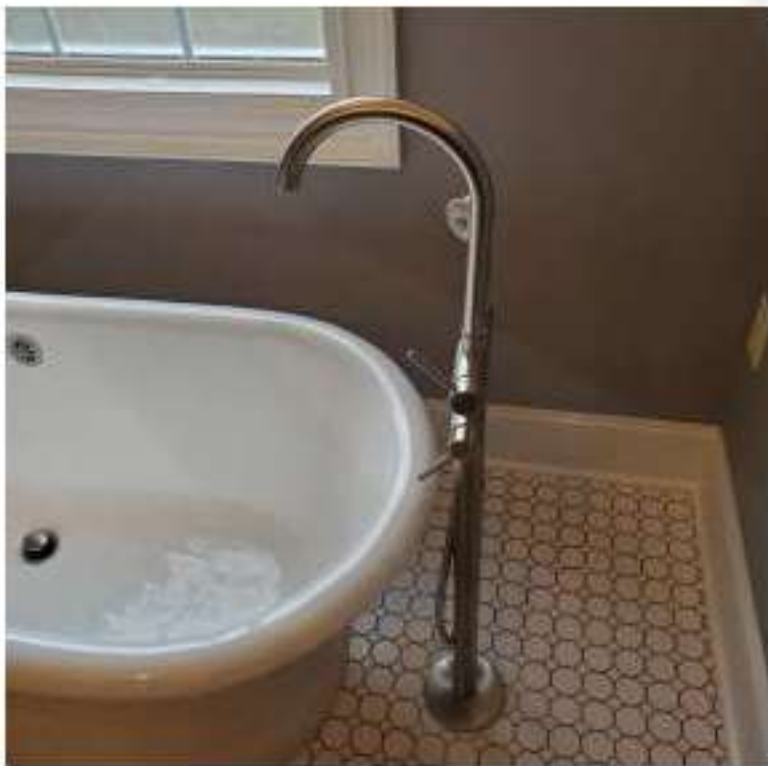
D. Faucet for tub in master bathroom would not turn on during testing

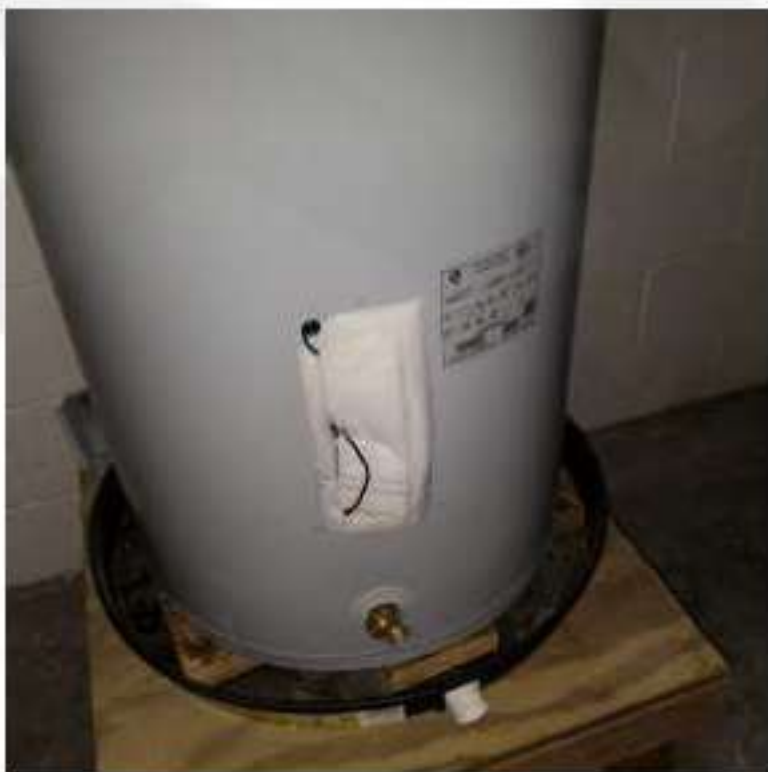
E. Missing cover for hot water control on heater in basement

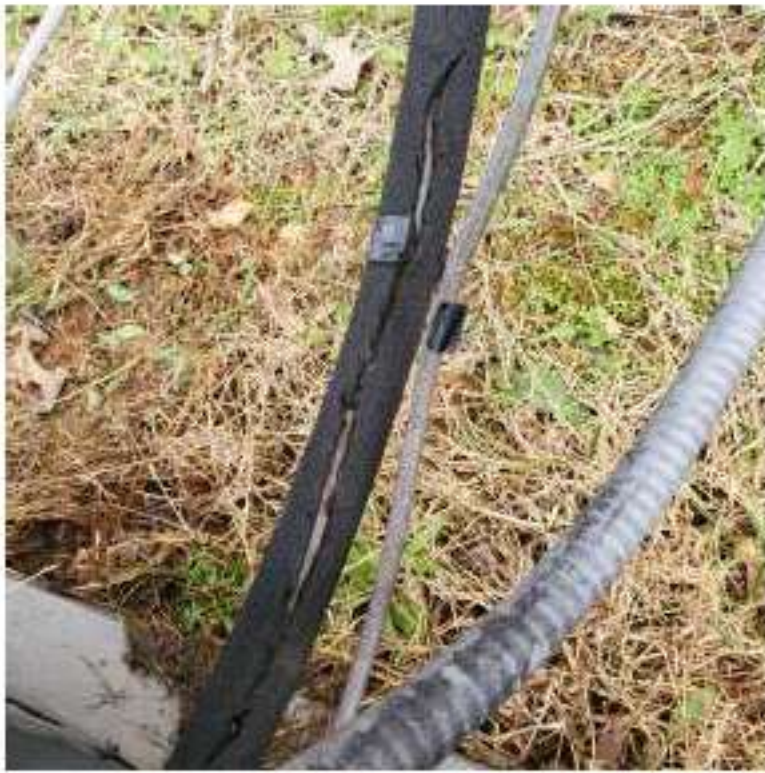
A. Insulation around suction line leading to condenser unit on left side of was damaged and should be replaced

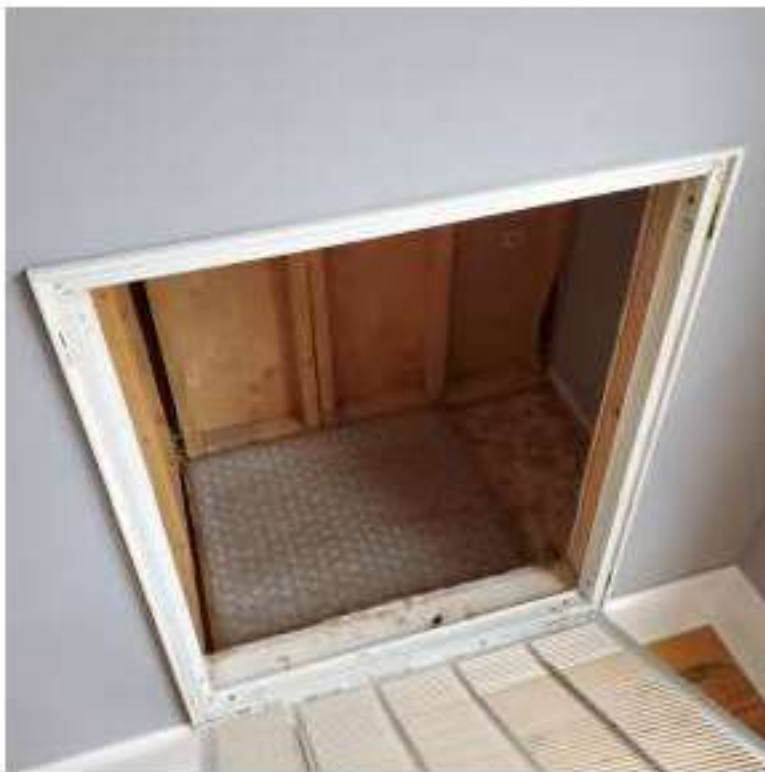
B. Return air vent filter was not properly installed in living room on first floor

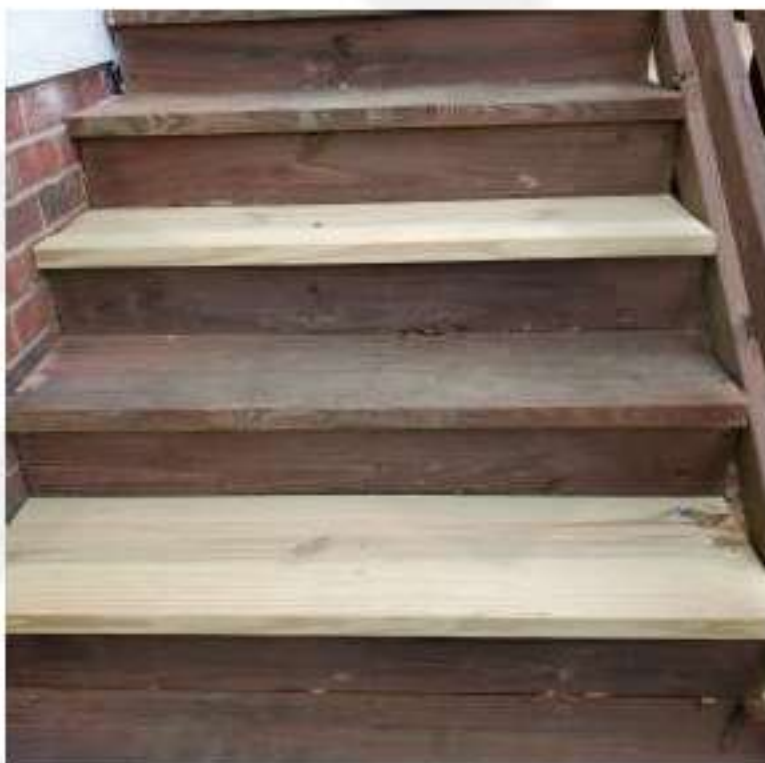
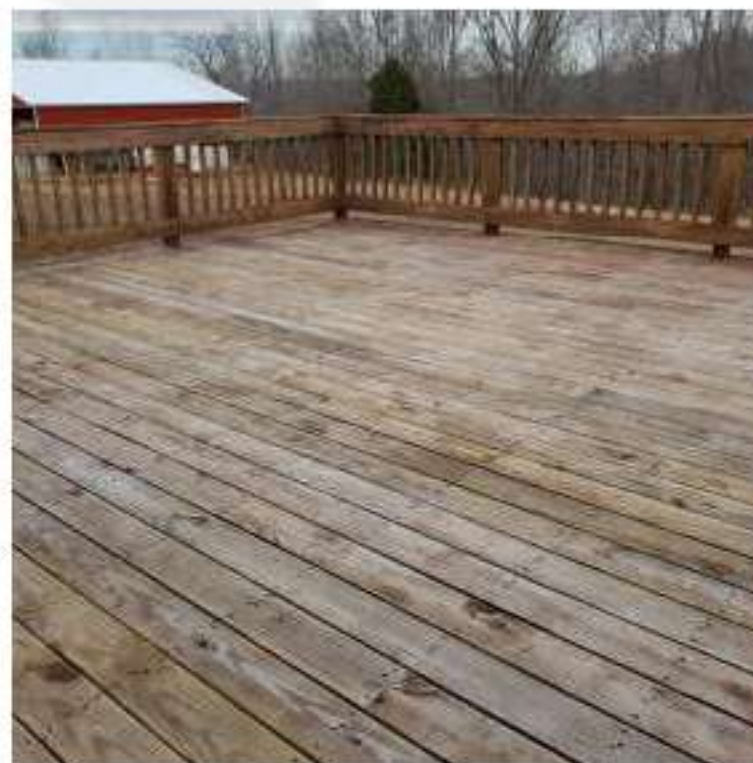
A. Recommend staining/sealing back deck during dry season to prevent moisture damage to wood

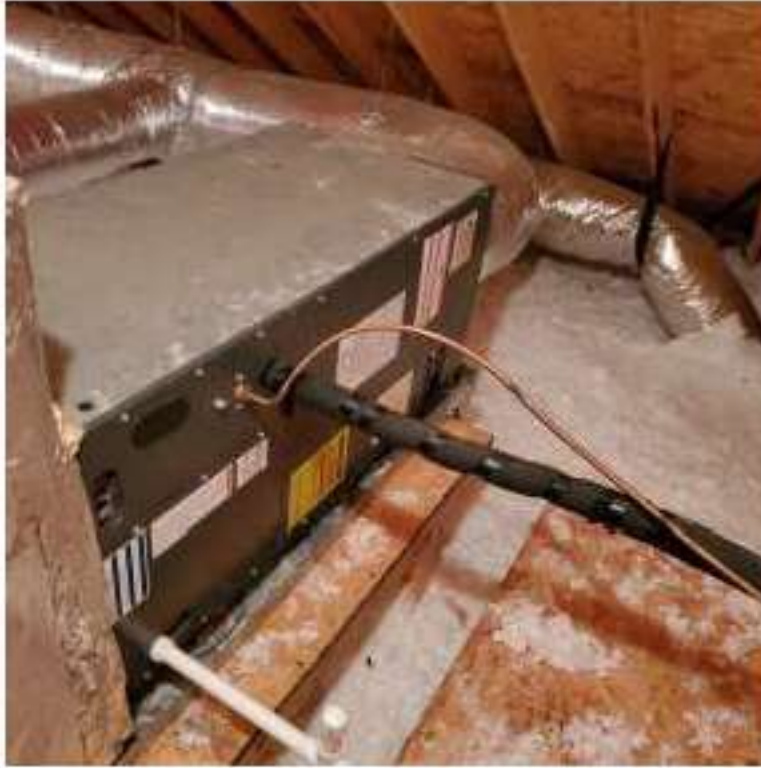
A. HVAC unit in attic manufactured in 2011

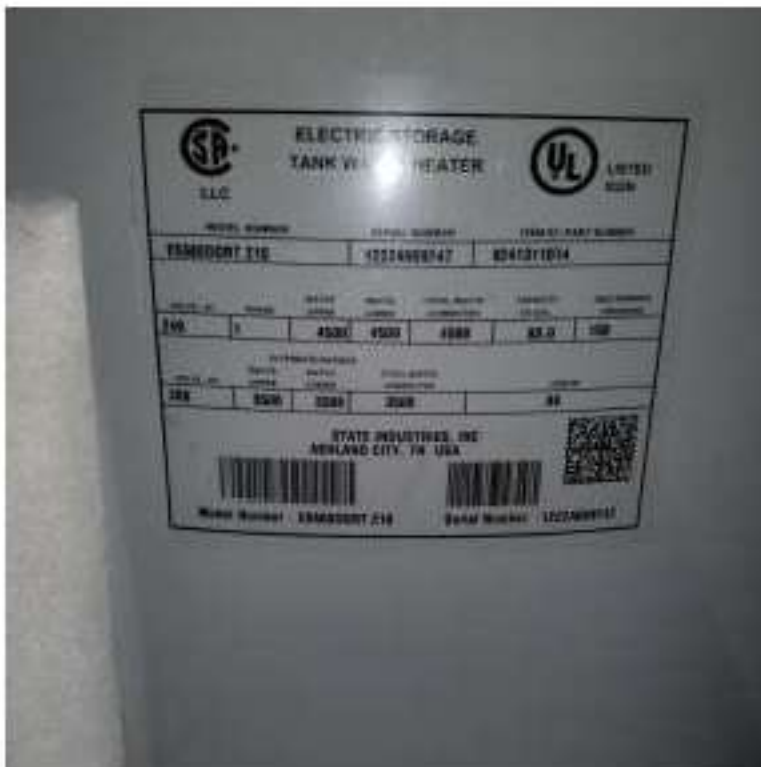
B. Hot water heater in basement manufactured in 2012

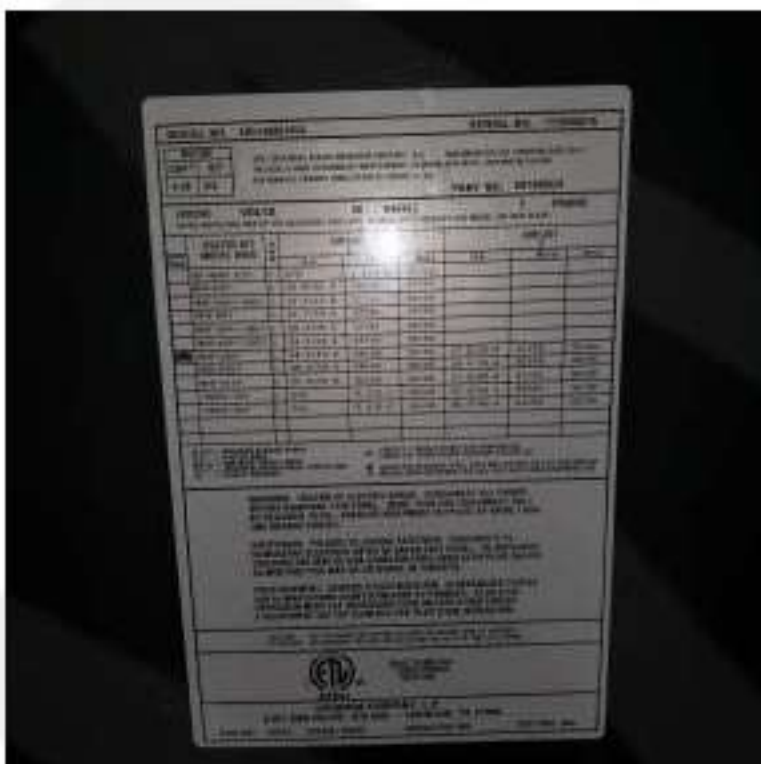
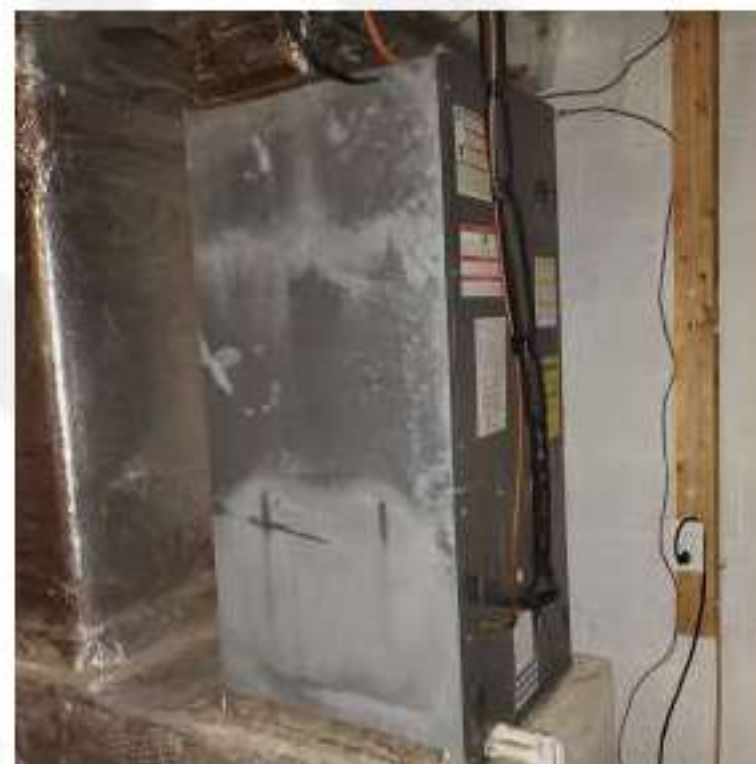
C. HVAC unit in basement was manufactured in 2011
